# Detection of Cracks in Aluminum Structure beneath Inconel Repair Bushings

Aging Aircraft Conference  
Phoenix Convention Center  
Phoenix, Arizona  
April 21-24, 2008

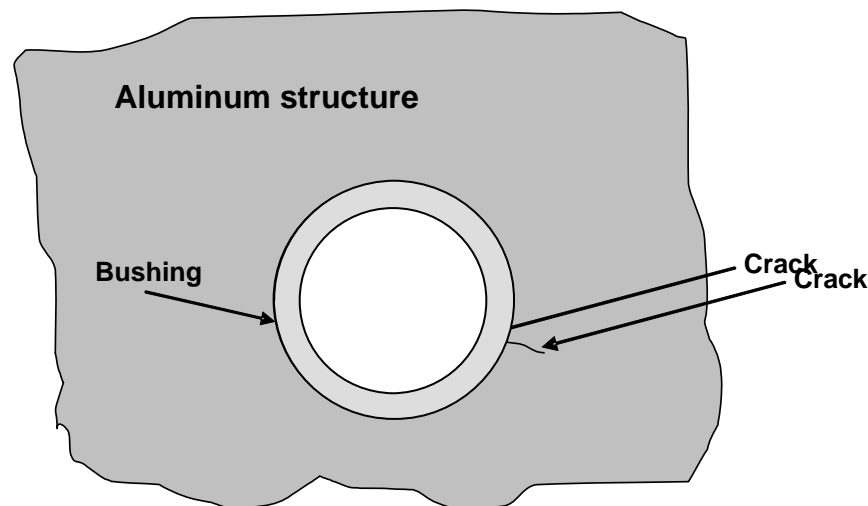
- Fatigue cracking at fastener holes is a common problem in military and commercial aircraft
- Some repair methodologies resort to oversizing the hole to remove the crack
  - Reaming
  - Installing a repair bushing to return the hole to its nominal size

- New cracking is now obscured by bushing

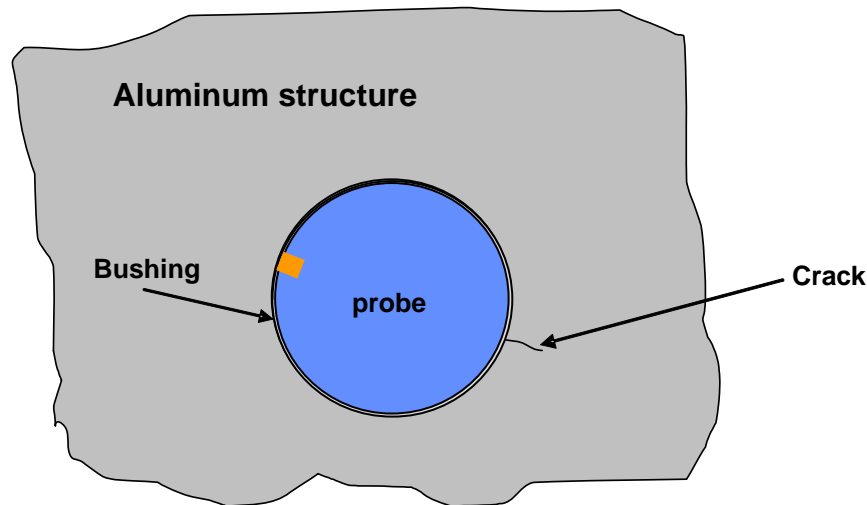
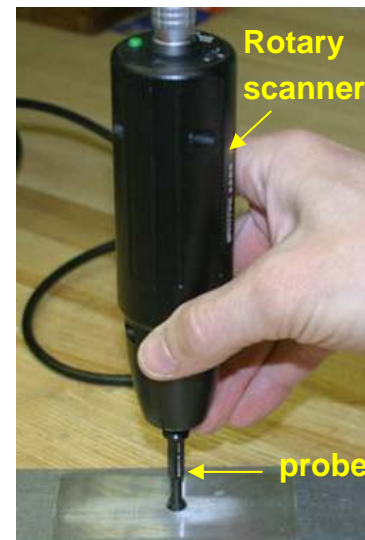
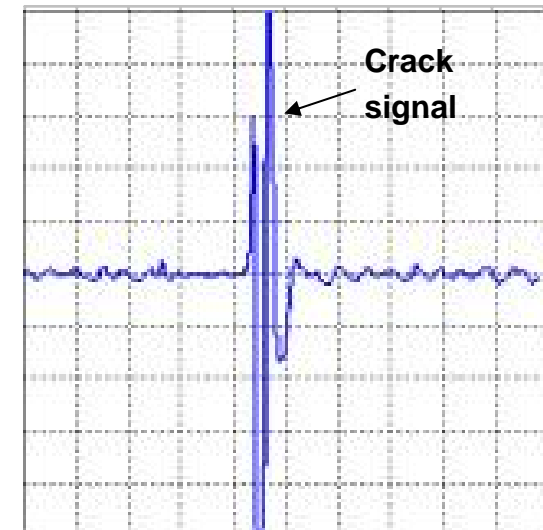
- Subsequent reinspection often requires
  - Conventional high-frequency (200-500kHz) bolt hole eddy current
    - Requires removal of the repair bushing for probe access
    - Inspection coil is placed against the inside diameter of the bolthole where the cracking initiates and rotated to produce inspection data

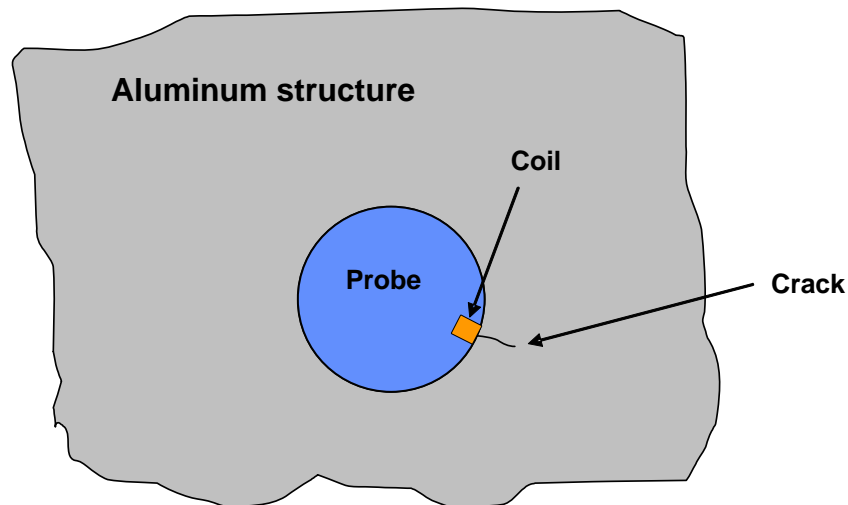
coil near crack in unbushed hole

- Bushing repairs
  - Bushing becomes a physical barrier between the eddy current coil and the crack,
  - Significantly affects sensitivity

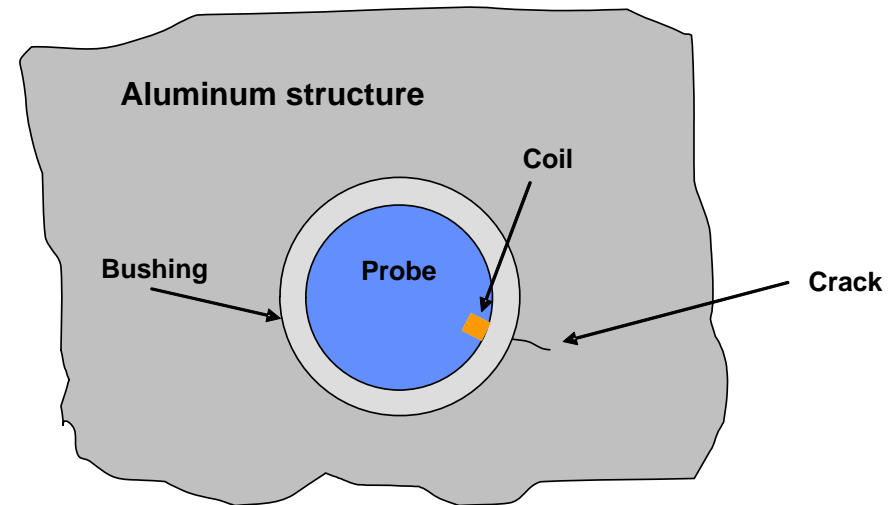
coil and crack separated physically by bushing

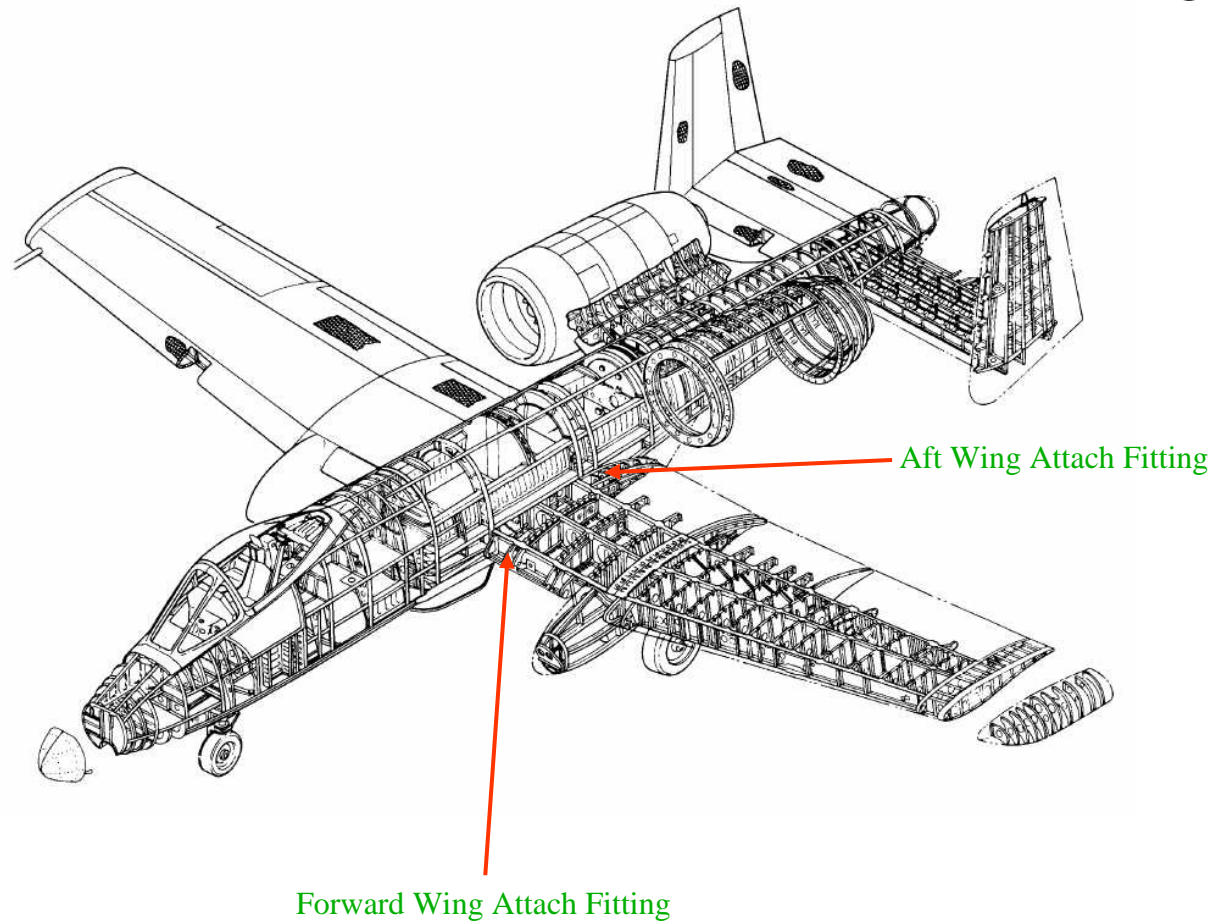
- A-10 Wing Station 23 Aft Wing Attachment Fitting

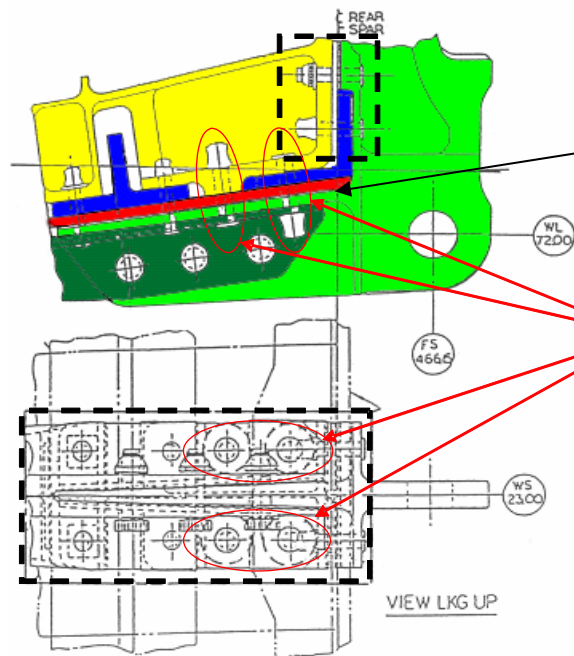
**Aft Fitting**

- Multi-layer stackup
- Corner cracks in ½ inch diameter aluminum fastener hole
  - Wing skin, spar cap, or rib layers

**Steel layer adjacent to crack in some instances!**

Inspection areas of interest

Rib (Y) – 0.310" 7075-T73 Al  
Shim – ≤0.094" Al Laminate  
Spar Cap (B) – 0.344" 2024-T3511 Al  
Skin (Red) – 0.300" 2024-T3511 Al  
Shim – ≤0.125" Al Laminate  
Attach Fitting (Lt Gr) – 0.320" 4340 Steel  
Shim – ≤0.094" Al Laminate  
Longeron (Dk Gr) – 0.200" 9Ni-4Co-.03C Steel

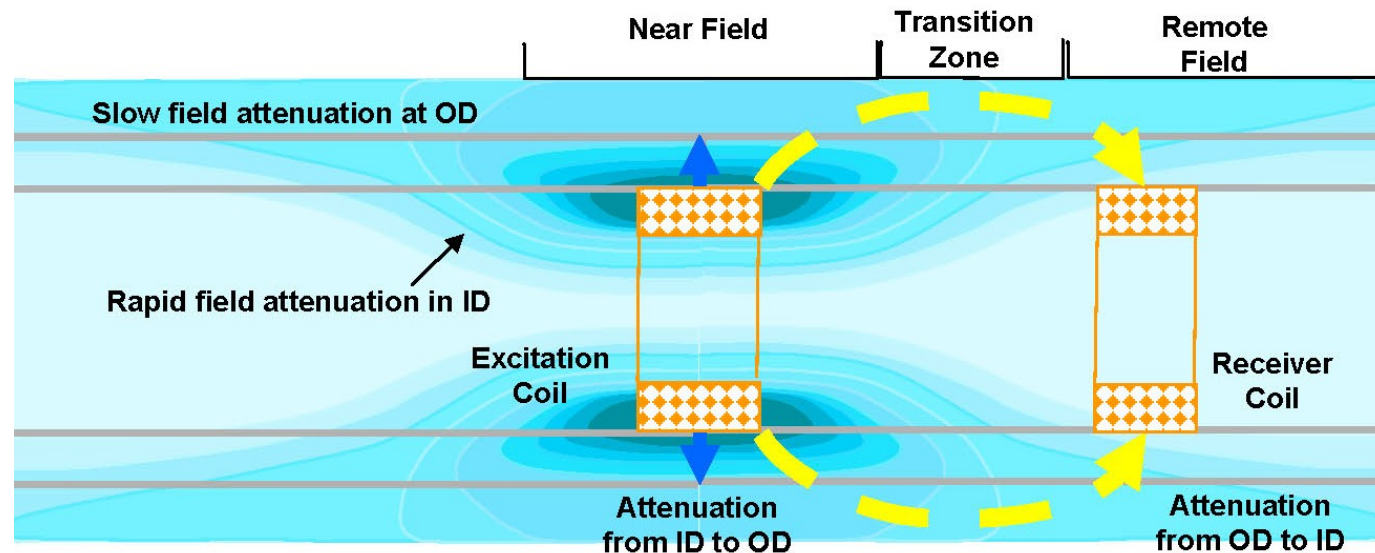
- Three primary zones:
  - 1) the direct coupling zone (nearest the exciter coil)
  - 2) the transition zone, and
  - 3) the remote field zone

- Since the directly coupled field decays at a faster rate, coil placement can be optimized to sense only the remote field

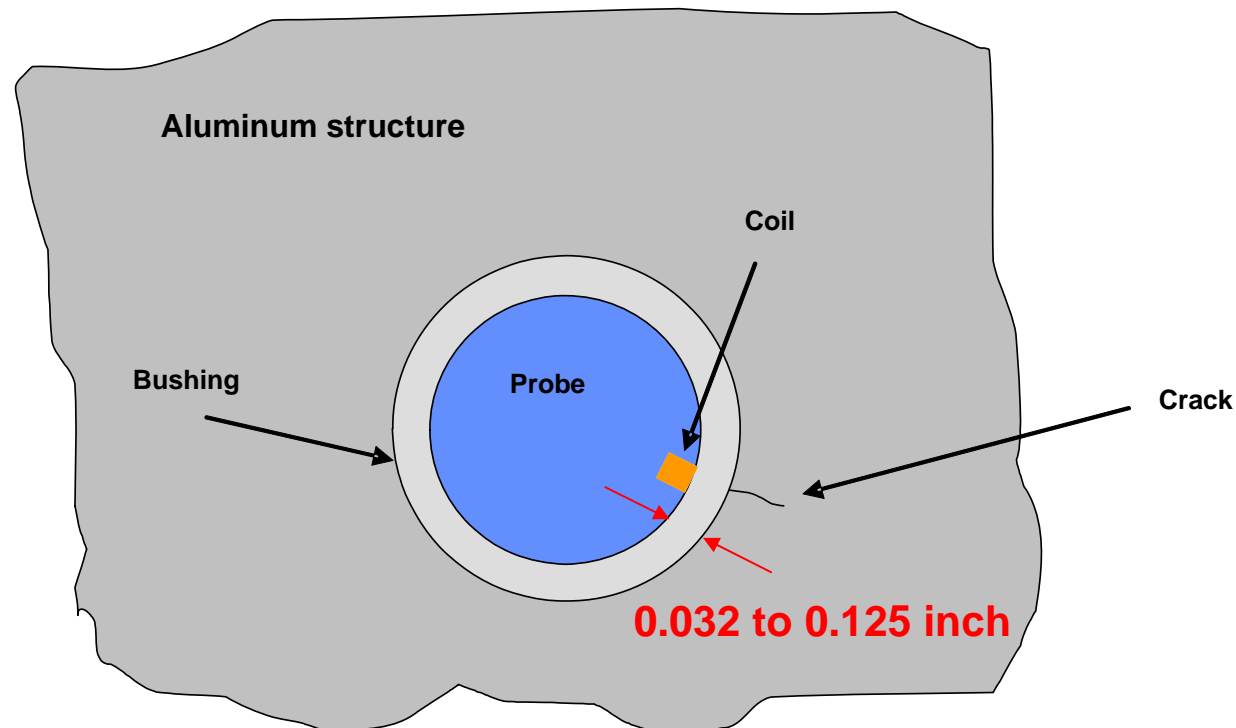
- However, for this application, conventional eddy current still struggles to produce a detectable crack response
  - Bushing wall thickness is a major factor

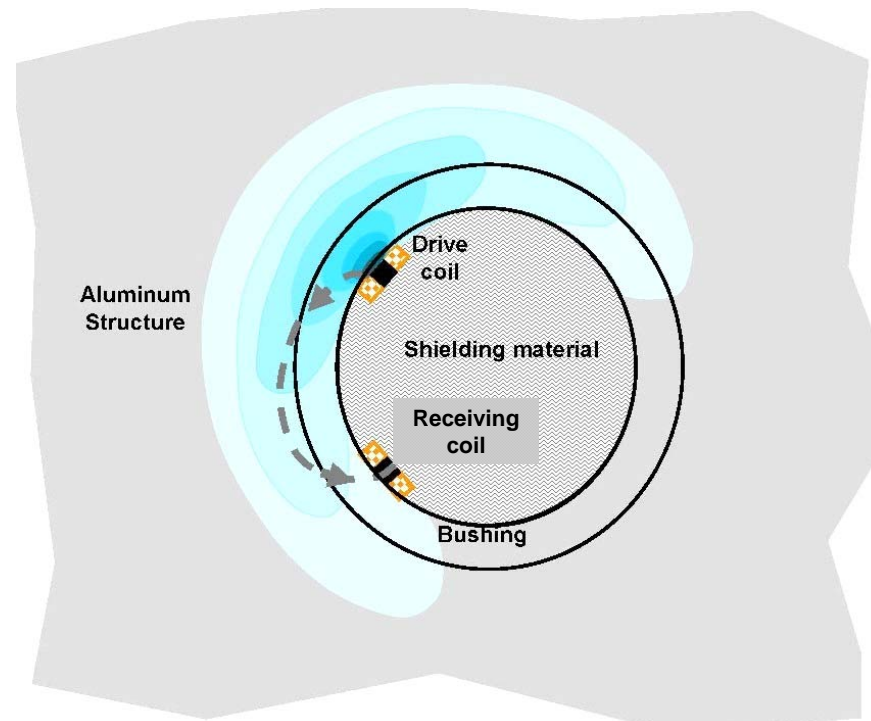
- **IMTT RFEC approach:**
  - Two probe coils in same rotational plane
  - Probe coil shielding prevents direct coupling
  - Receiving coil detects only the remote field

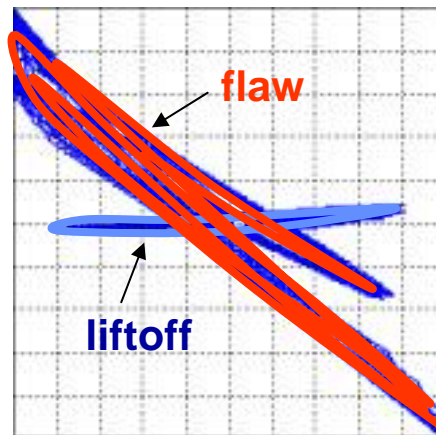
Impedance plane

- Signals are similar to conventional bolt hole eddy current
  - Impedance plane
    - Probe liftoff, “real” component, oriented in X-direction
    - Flaw response, “imaginary” component, appears at a rotated phase
  - Sweep display
    - Indicates clock position of flaw in hole

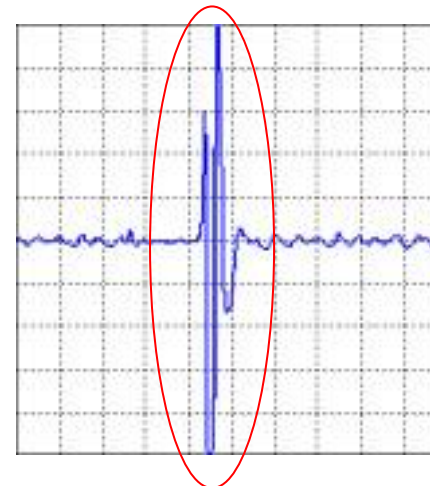
Sweep display

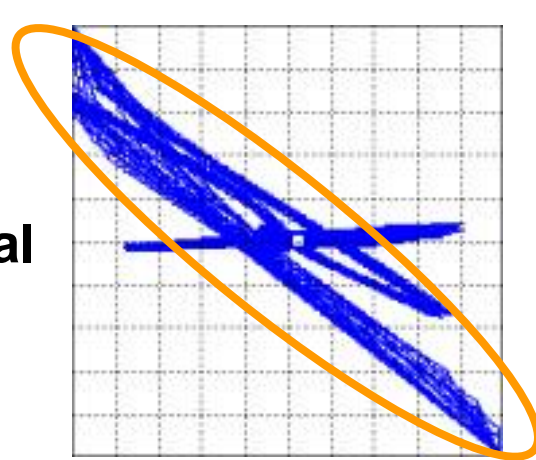
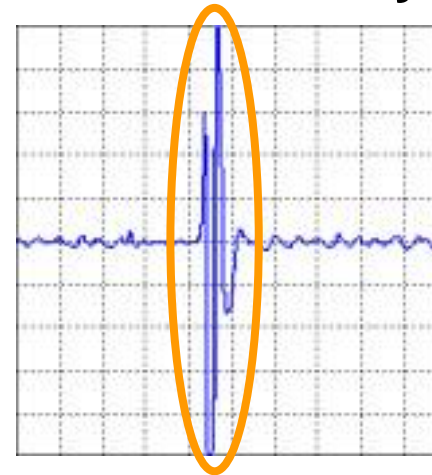
Conventional

- Signals are similar to conventional bolt hole eddy current

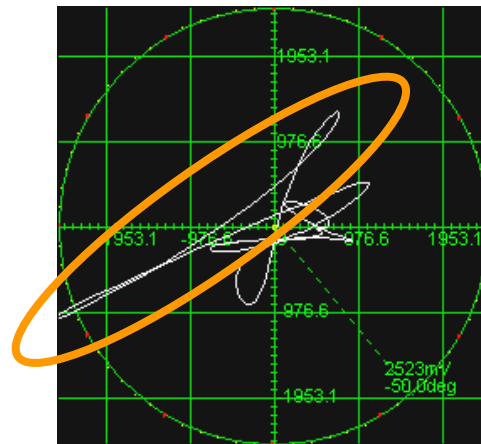
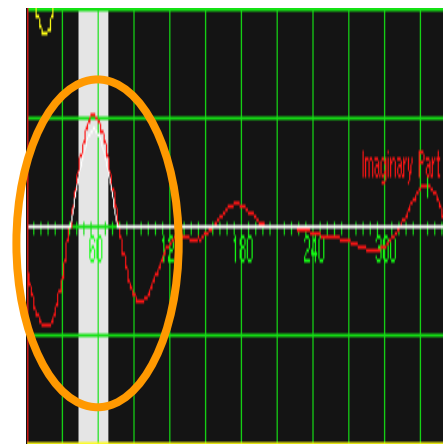
RFEC

Impedance plane

Sweep display

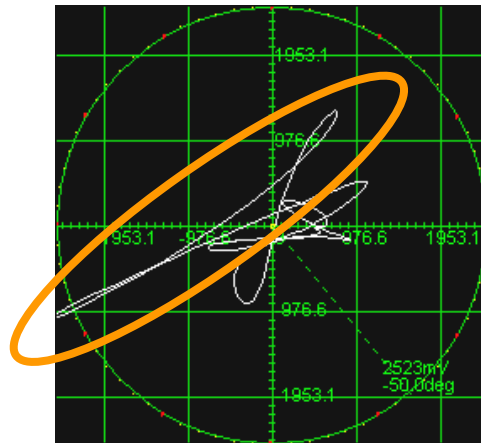
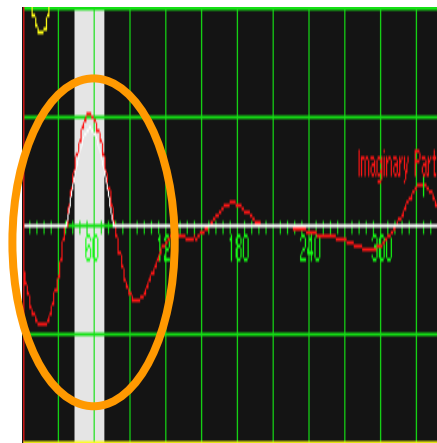
- Remote field signal
  - Relatively weak, broad, “noisy”
  - Influenced by local geometry and materials
  - Signal Recognition Algorithm employed

Impedance plane

Sweep display

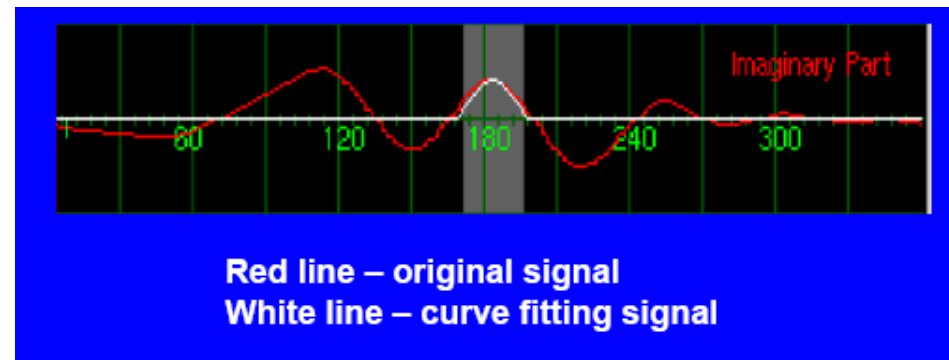
- **Signal Recognition Algorithm**
  - **Flaw produces broad “W” shaped response**

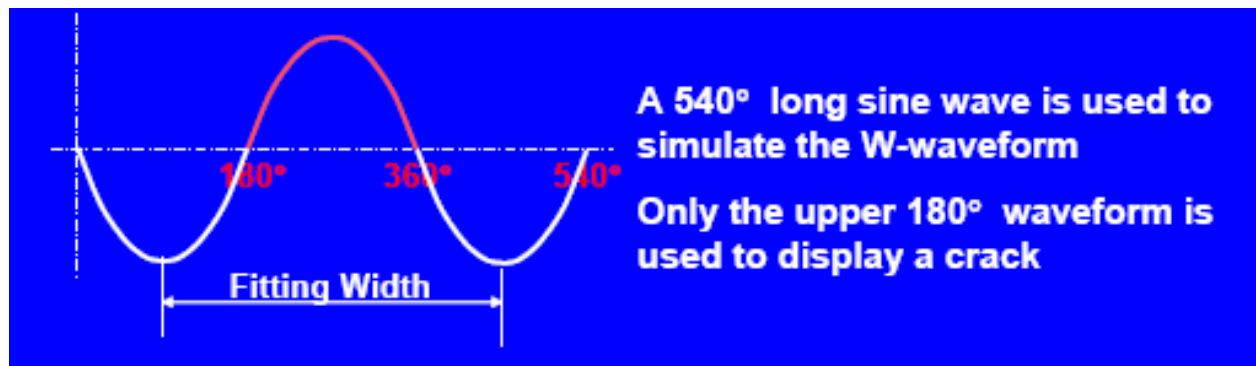
- **Artificial waveform automatically generated to represent flaw response (RMS)**

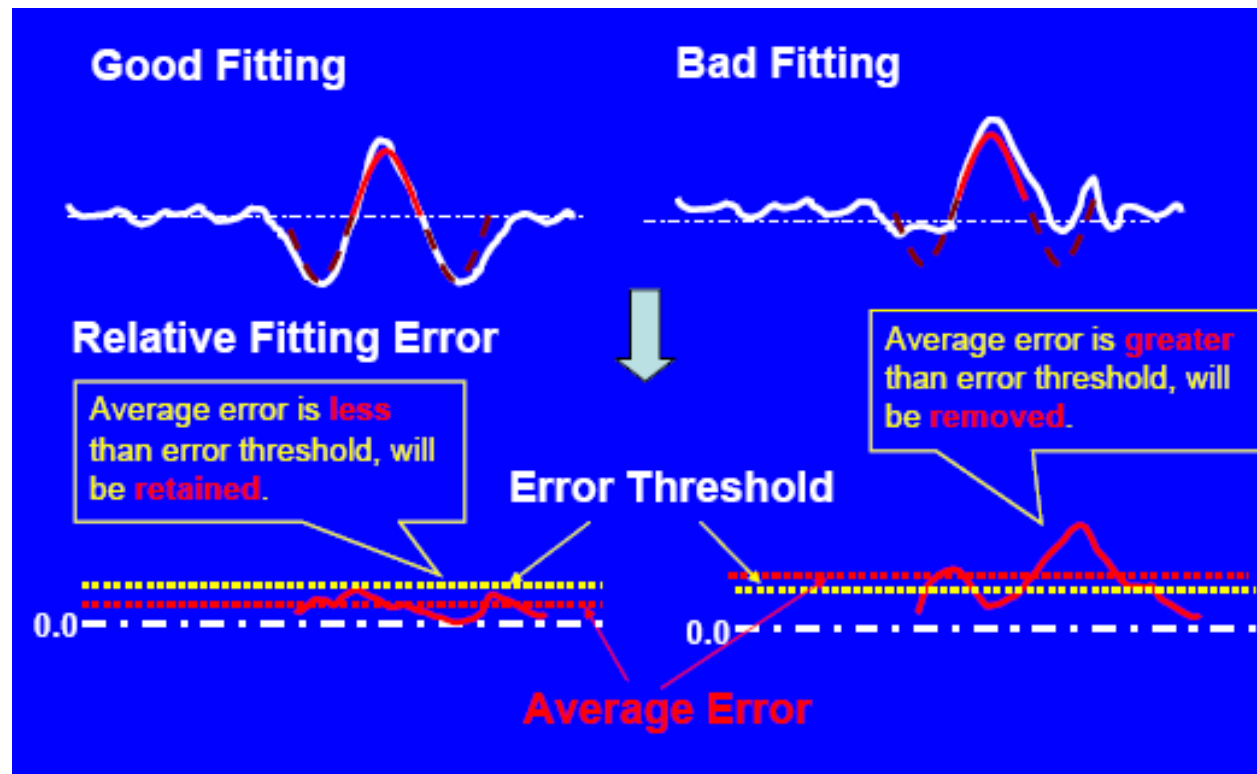
- Error threshold selected by user
  - Defines how well artificial waveform must match real signal

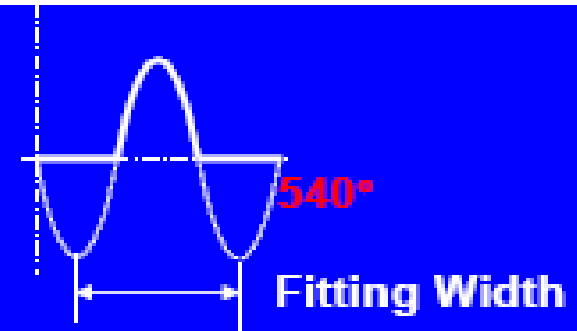
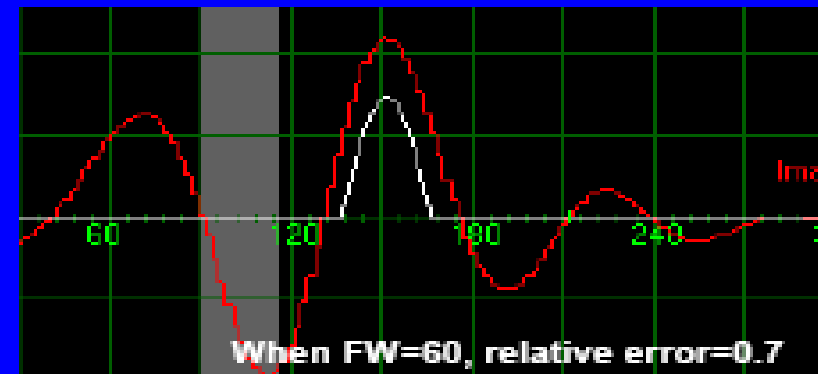
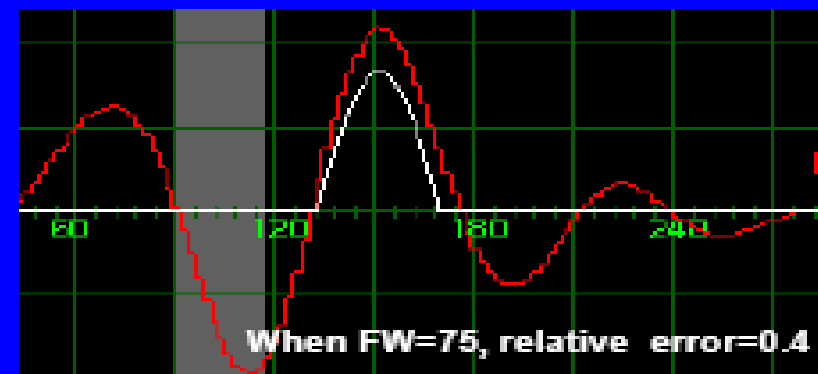
- “Fitting width” selected by user
  - Width of a flaw response is fairly repeatable
    - Physical width of a crack does not vary significantly
    - Narrower width response than many non-relevant features such as oblong holes, mechanical contact during scanning, uneven liftoff, etc.

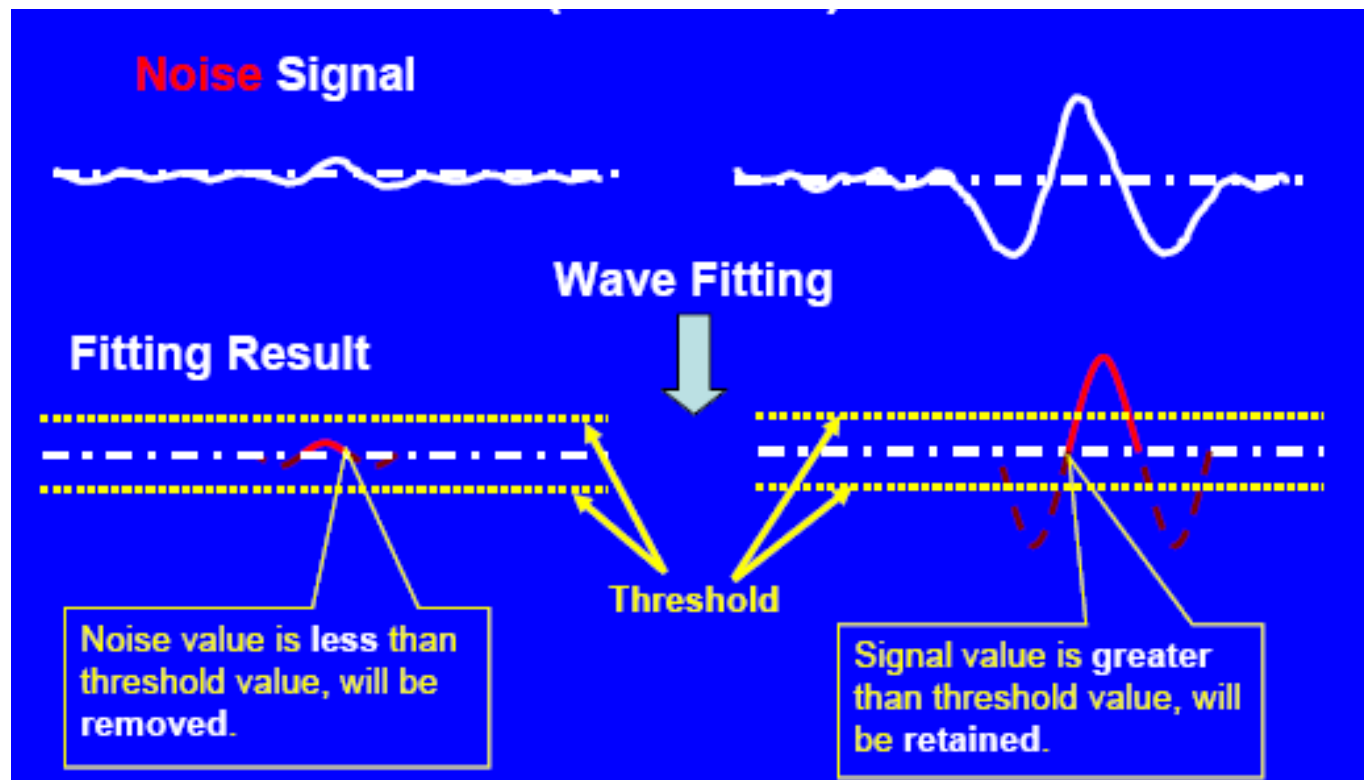
- **Magnitude (noise) threshold is selected by user**
  - **Similar to noise threshold selection in conventional eddy current**

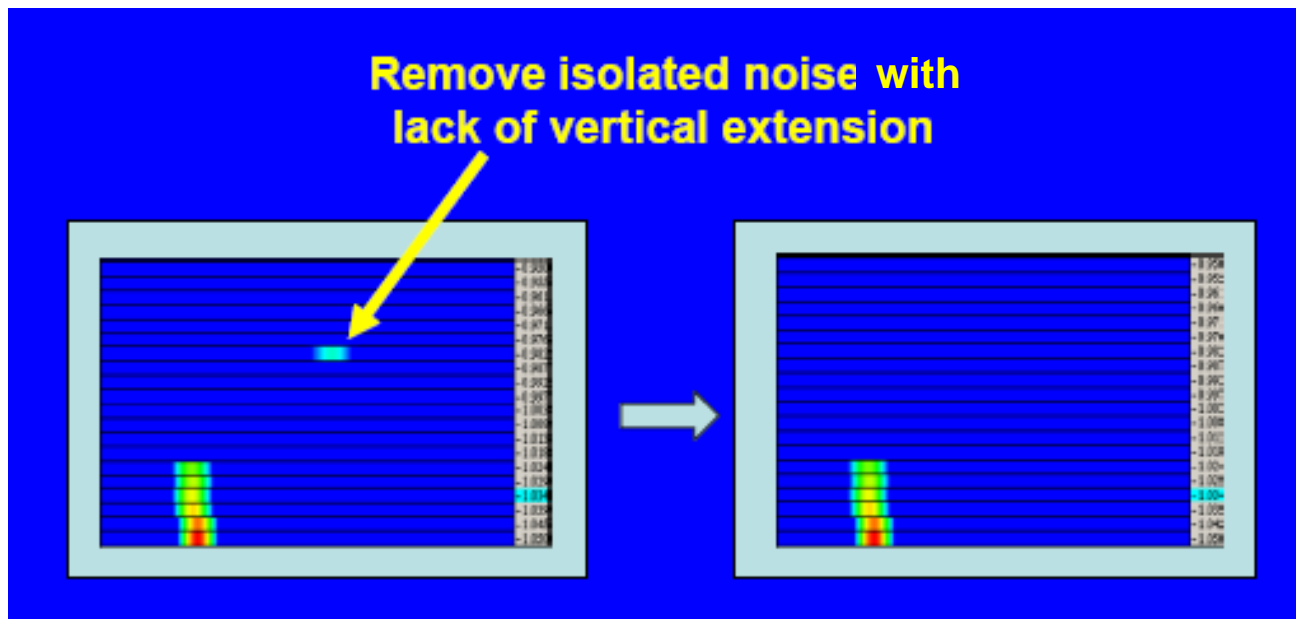
- “Fitting pick” is selected by user
  - Inspection noise can appear “crack-like”
- But typically very localized, intermittent
  - Does not continue in z-direction of scan

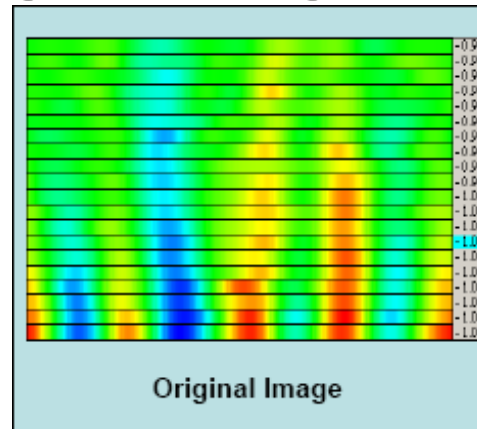
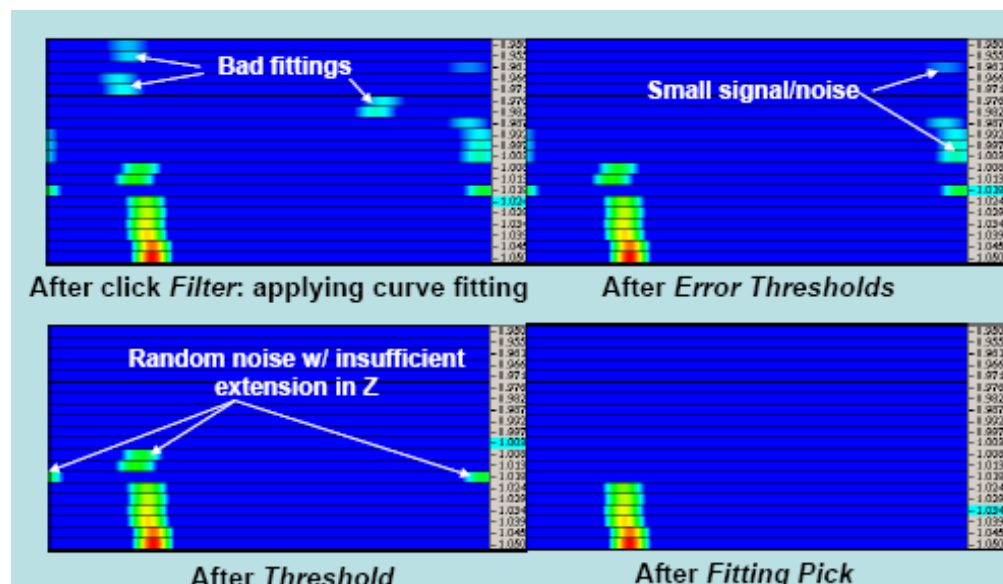
- Combination of signal recognition algorithms:

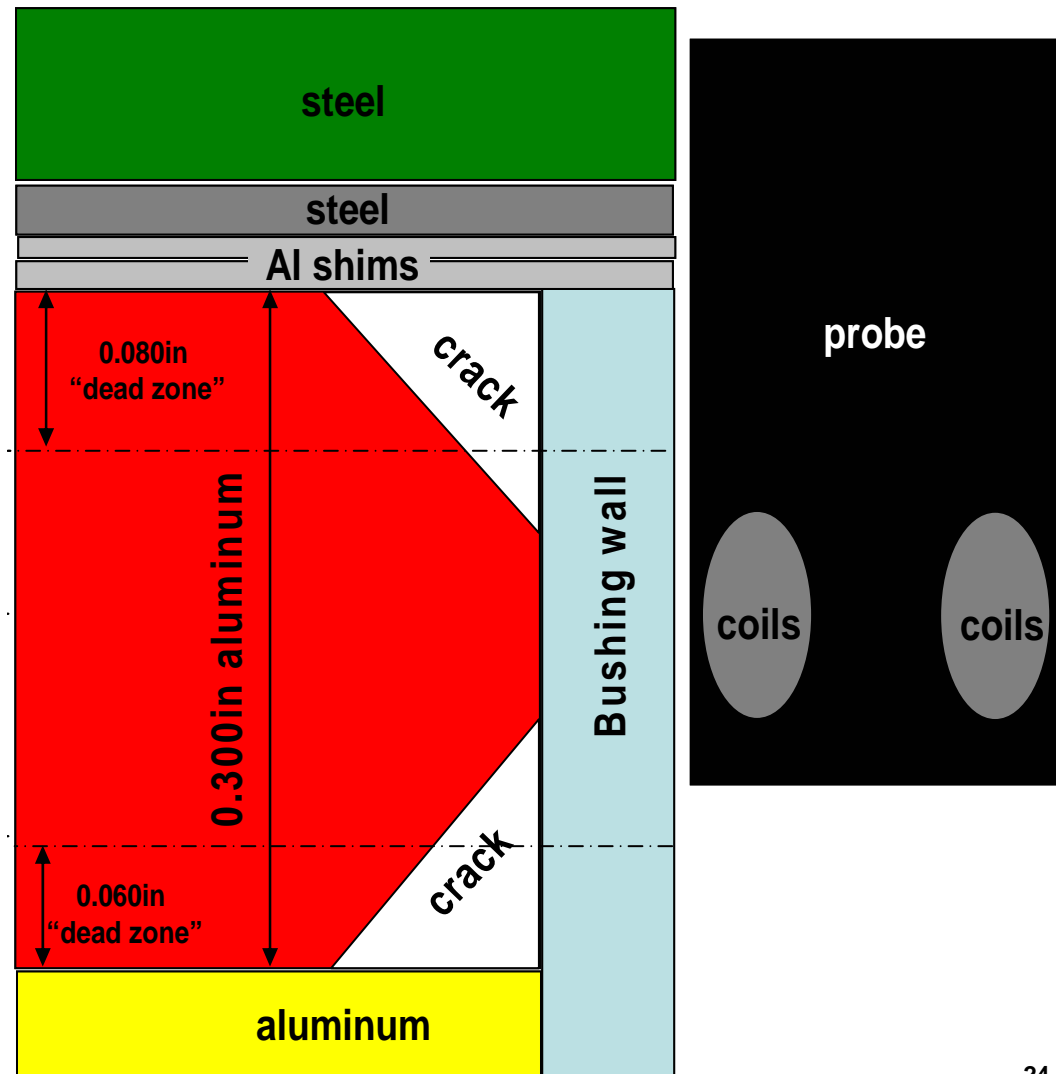
- “Dead zones” near interfaces
  - Discontinuous surface produces a crack-like response 5-10 times larger in amplitude than a 0.050-0.100 inch corner flaw
  - Size of “dead zone” varies with bushing configuration and adjacent material layers
  - Fortunately, cracks as small as 0.050 x 0.050, can still be detected beyond the dead zones!

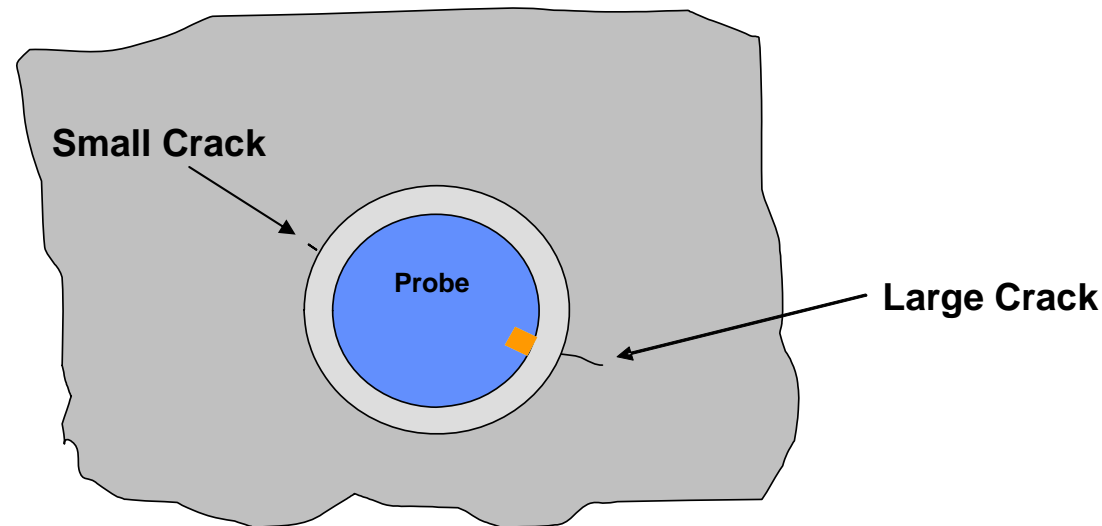
- **Multiple cracks in the same plane**
  - The current algorithm will only identify the largest flaw in a plane and assign the artificial signal to it
    - A second (smaller) crack in the same plane will be ignored

- Spacing of cracks may also affect algorithm performance

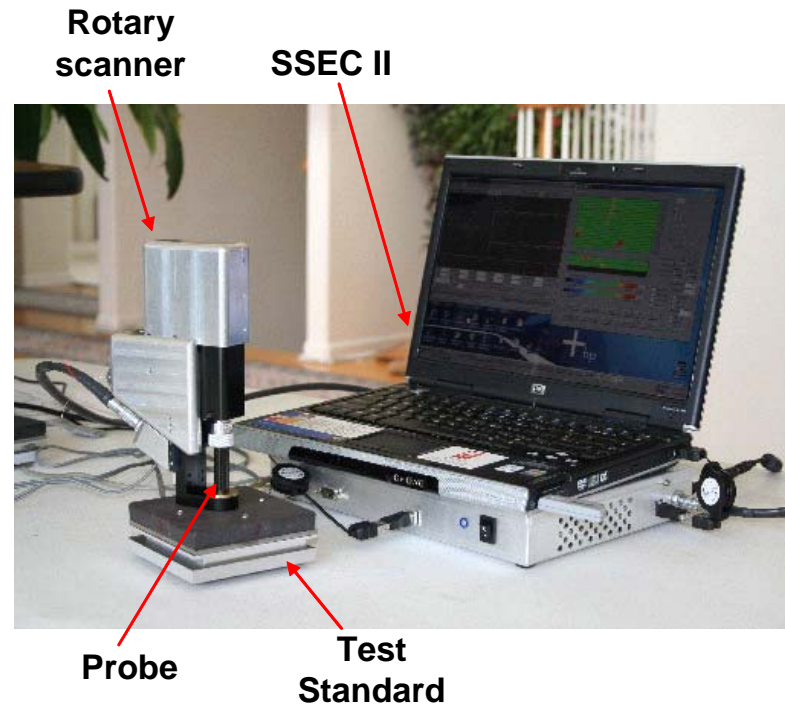
- **SSEC II is a laptop computer based eddy current instrument**
  - Controls the probe and scanner
  - Impedance plane, sweep, and C-scan formats in near real time
  - Custom software
  - unique signal recognition algorithms

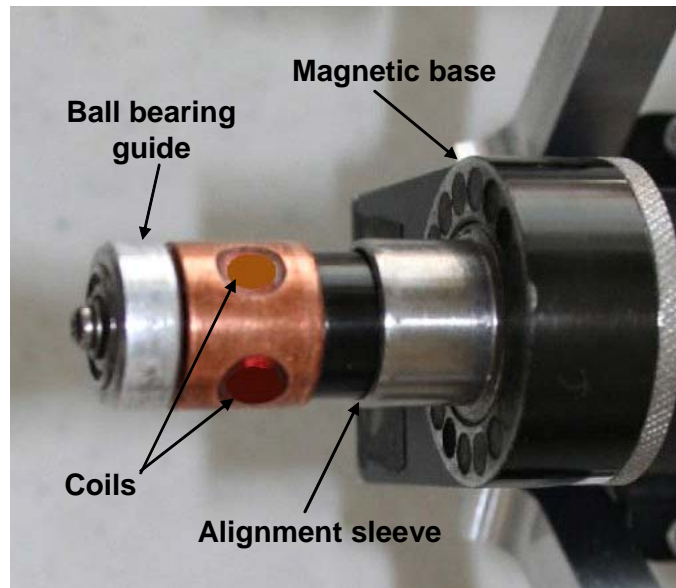
- **Probe**
  - **shielded coils (8-50kHz range)**
    - **aligned circumferentially**
  - **self-centering ball-bearing guide to prevent coil contact with the bushing wall**

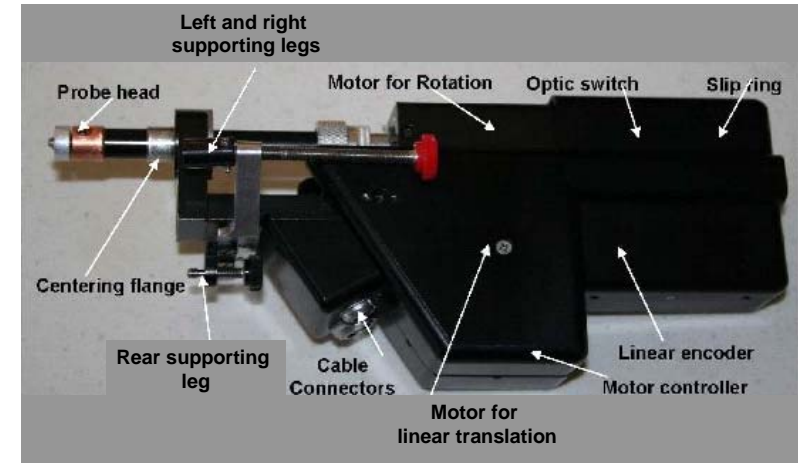
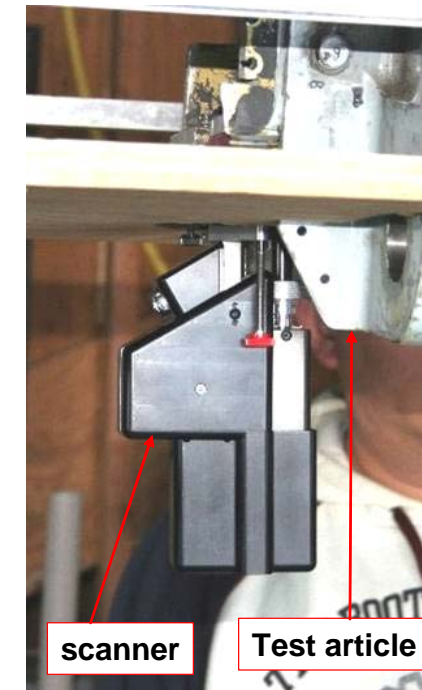
- **Rotary scanner**
  - Slip ring (sliding electrical contact) design
  - Probe adapter - alignment collar
  - Magnetic base - to attach to the steel external layer
    - “hands-free” inspection in inverted position
  - Scan times ~ 0.3in/min
    - Conventional high frequency bolt hole eddy current ~ 0.3in/sec.
  - Indexing optimized to 0.010 in for this application (0.003 possible)

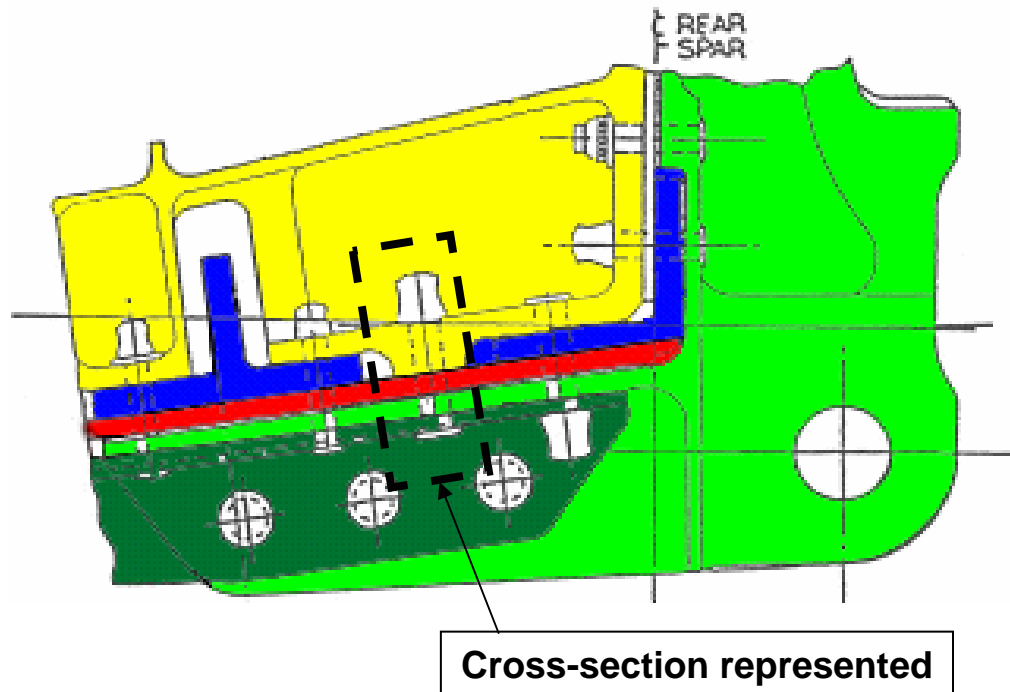
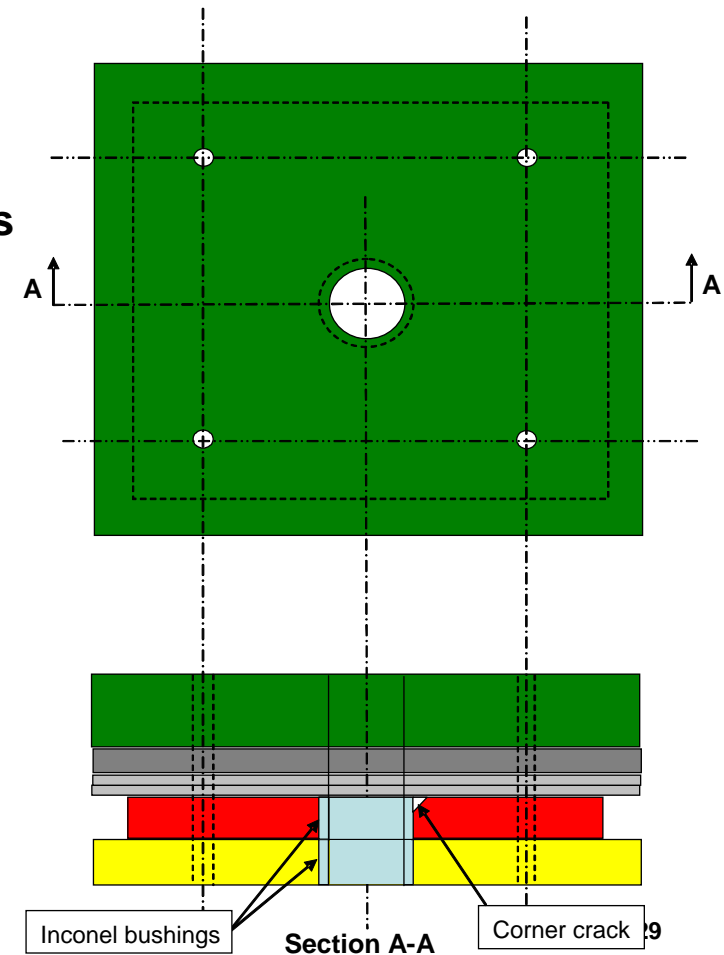
- **Laboratory manufactured test standards**

- Repair bushings of various wall thicknesses
  - 0.032 to 0.125 inches thick
- Corner cracks or corner EDMs
  - 0.060 x 0.020 inches to 0.120 x 0.130 inches

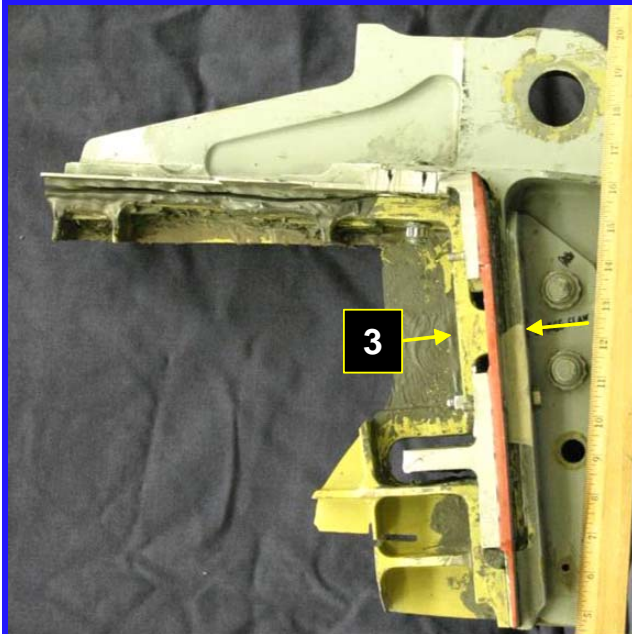
0.090" at interface x 0.075" into bore

- Two 0.532" diameter holes with Inconel bushings installed (yellow arrows/red outlined holes).
  - Hole #3, large crack, 0.075 x 0.090
  - Hole #4, small crack, 0.060 x 0.020
- Cracks at wing skin layer (red layer)

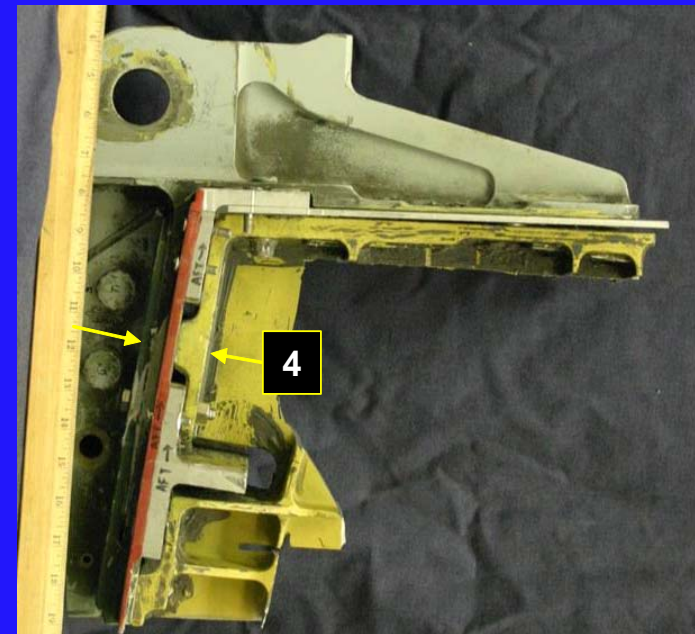
0.020" at interface x 0.060" into bore

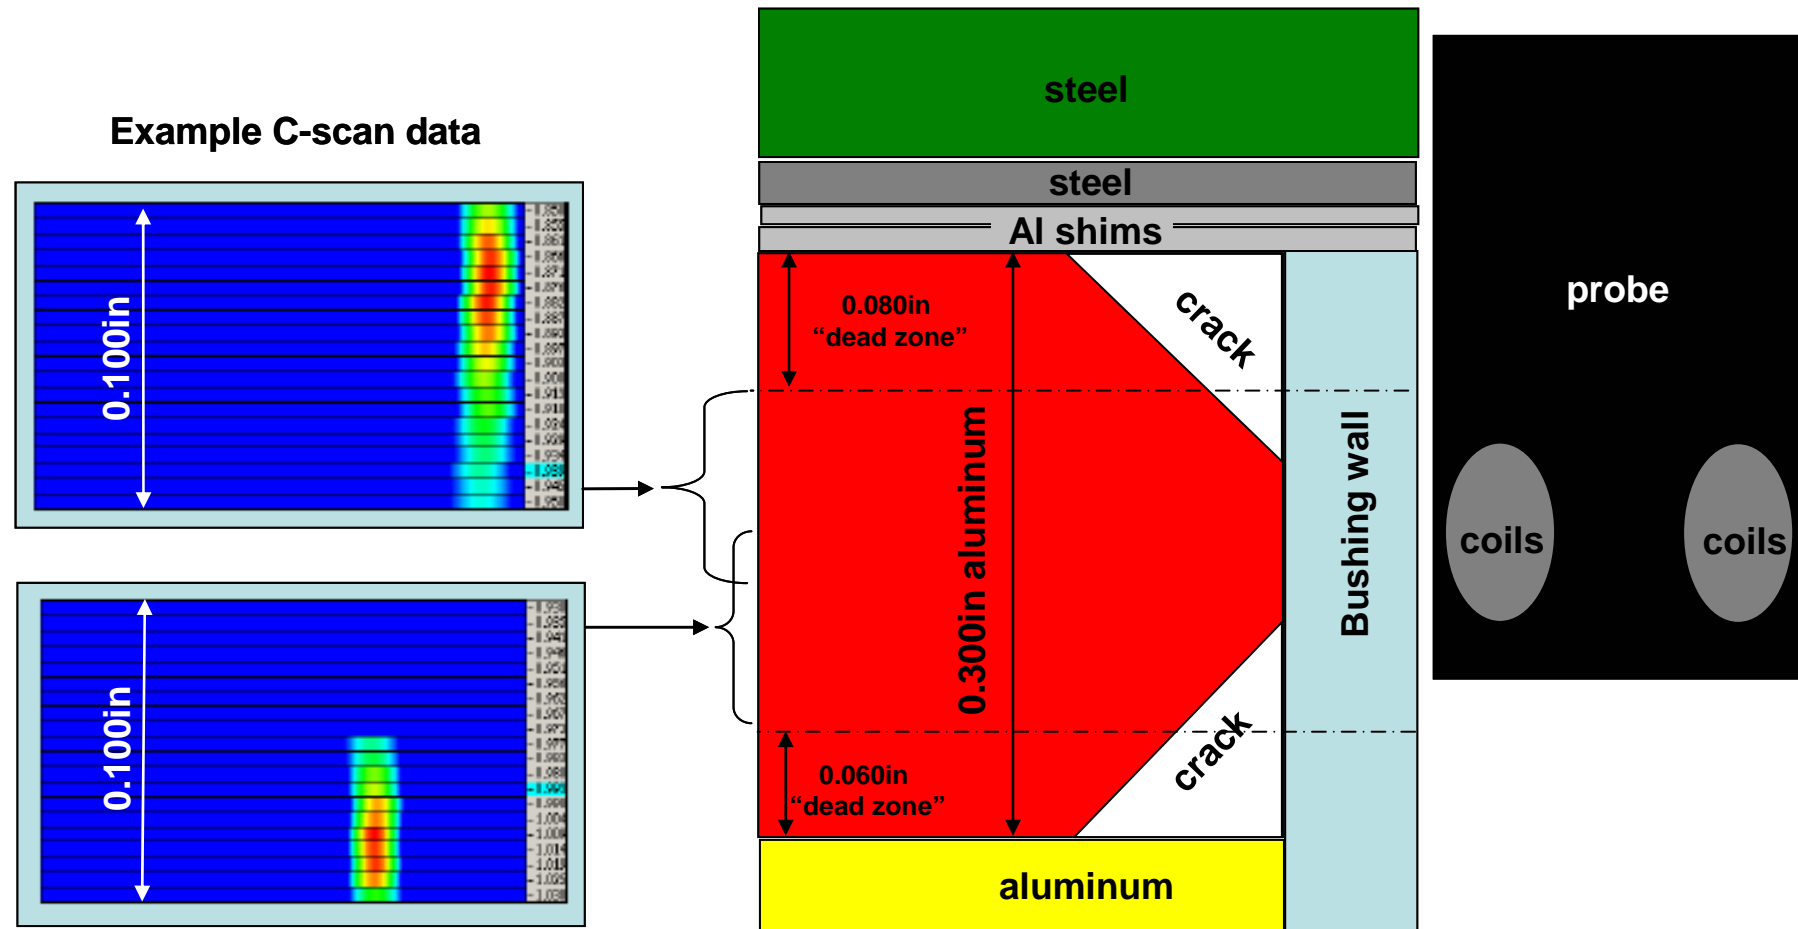
**All flaws detected in all test articles/coupons!**
